Corrosion Induced Loss of Capacity of Post-Tensioned Seven Wire Strand Cable Used in Multistrand Anchor Systems Installed at Corps Projects

Robert M. Ebeling, Barry C. White, James A. Evans,
Richard W. Haskins, and Ernest L. Miller

December 2016

Final report

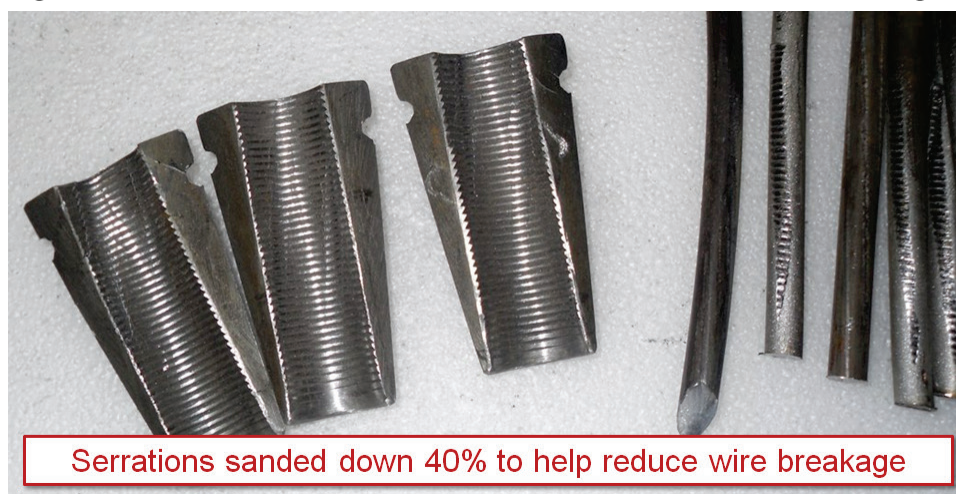
Method 8: Removing about 40% of the serrations (Figure 2.8). There was a slight slippage of the cable in the wedge. When it gripped, the serrations bit into the cable, causing the cable to break consistently at one of the wedges.

Figure 2.8. Pull-test results of PT seven-wire strand cable with 40% reduced wedges.

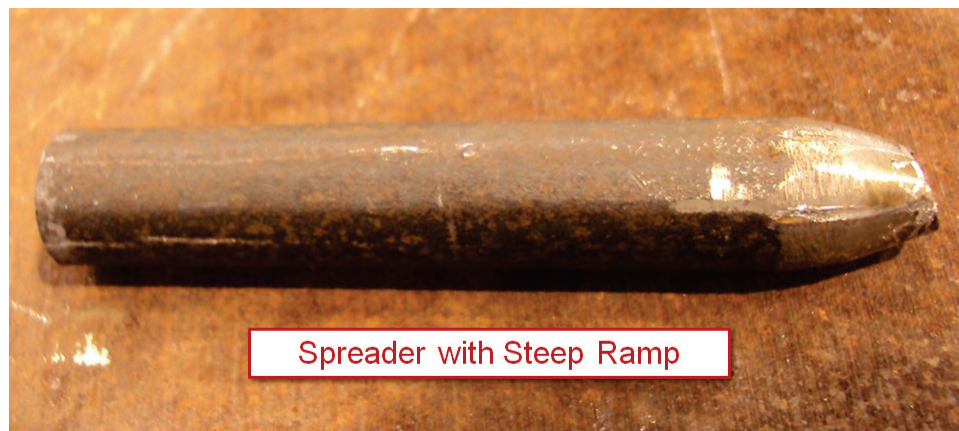
Figure 2.10. Spreader to be driven on the king wire with a steep slope.

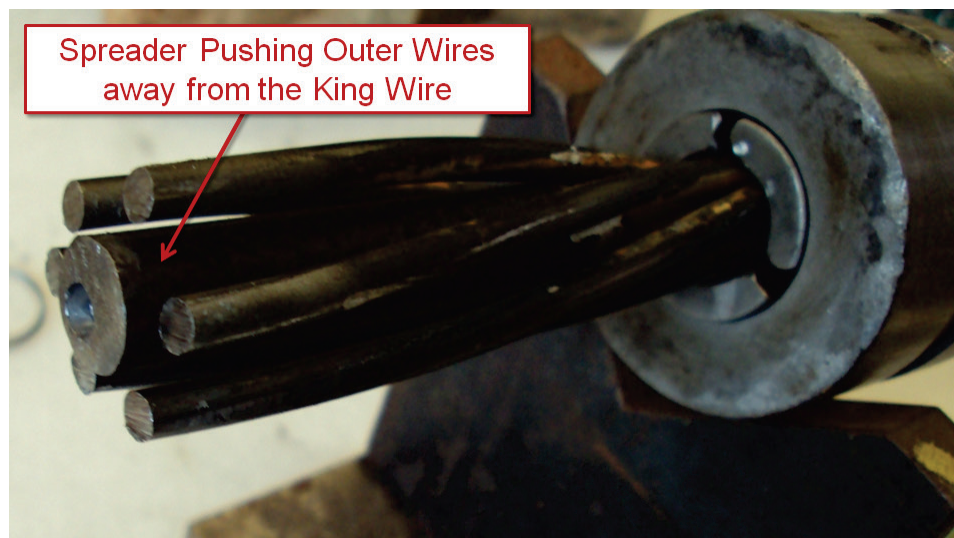
Figure 2.12. Connection details of wire with spreader and the interface with the wedge.

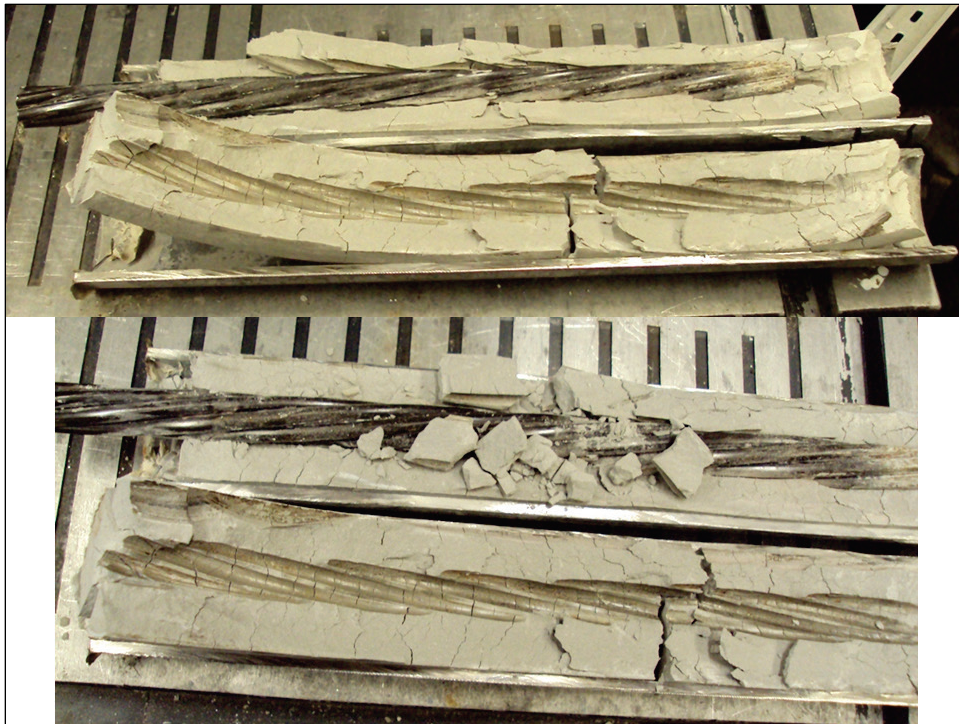
Figure 2.17. Examples of the grout turning to dust as the cable attempted to twist at the connection.

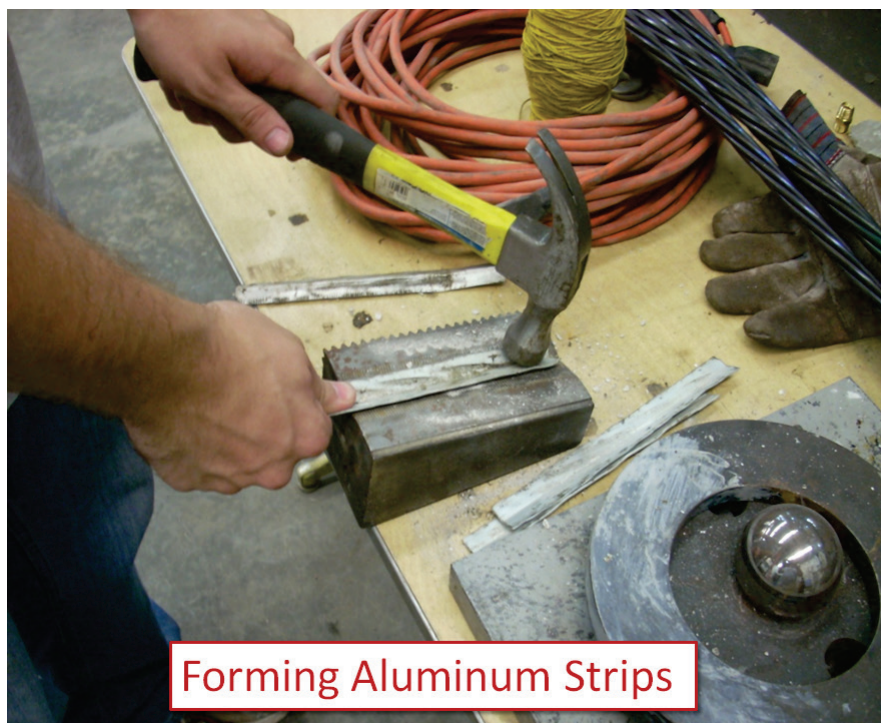
Figure 2.19. Hammering aluminum strips into the wedges to form grip points with the serrations.

Method 12: Based on the dissertation work of Robert Moser (2011), a light sand mixture was formed and bound around the cable with two aluminum strips formed into the shape of the wedges. Two 1.5 in. x 8 in. x 0.125 in. aluminum strips were shaped to the form of the large wedges seen in Figure 2.19. Hammering the aluminum strips into the wedges caused the scalloped indentations in the wedge to indent the aluminum, strengthening the grip of the aluminum strips within the wedge (Figures 2.19 and 2.20). Then light wet sand was mixed, formed around the cable, and the two aluminum pieces were cable-tied around the sand and cable directly across from each other (Figure 2.21). This method for gripping the pristine cable (Figure 2.22) produced consistent breakage in the middle part of the cable, but was very time consuming. In this case, the end length of cable was gripped by the aluminum and the sand enclosure was nearly 11 in. Cable failure occurred away from the grips. Then, the procedure was used on 22 pristine cable specimens. None of the failures occurred at the grips.

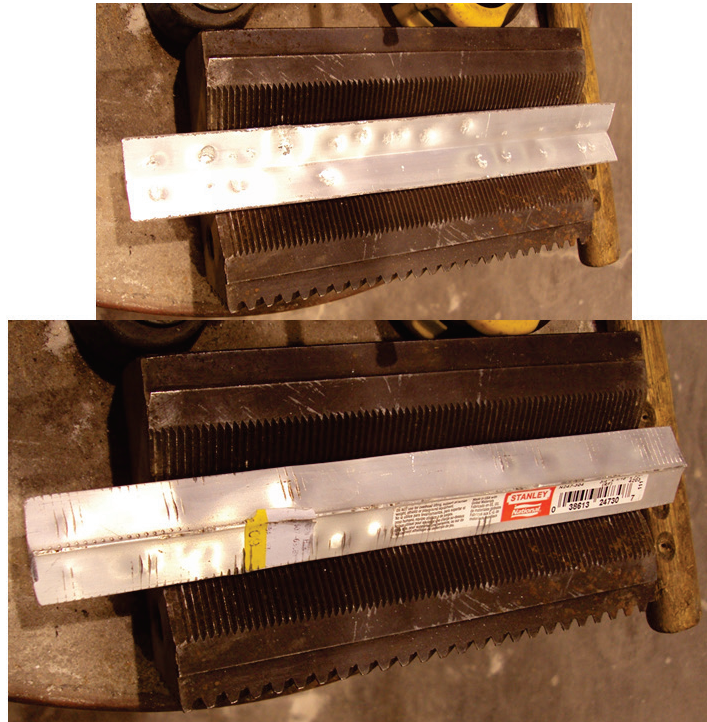
Figure 2.20. Hammered grip point details for the wedges.
Note how the aluminum strip was hammered and the gripping
surface, respectively.

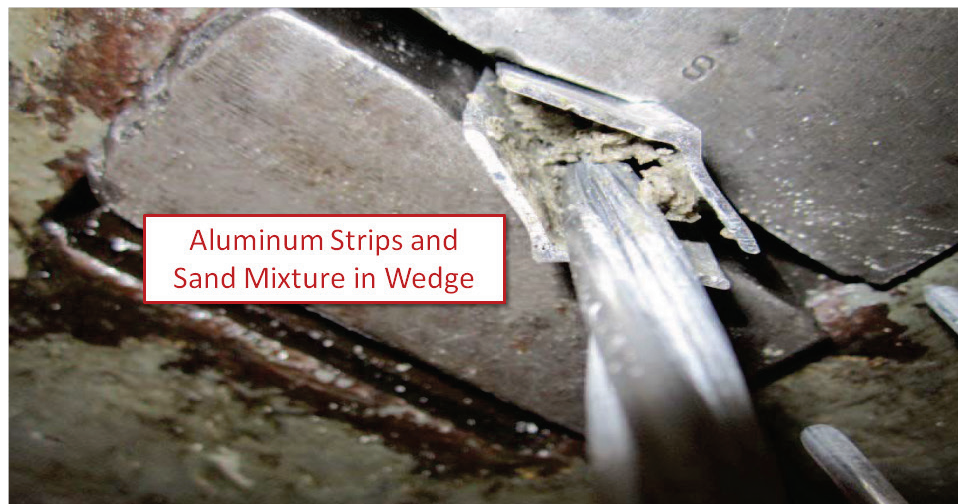
Figure 2.22. Aluminum strips with sand mixture restraining the PT seven-wire strand cable and being held in place by wedges.

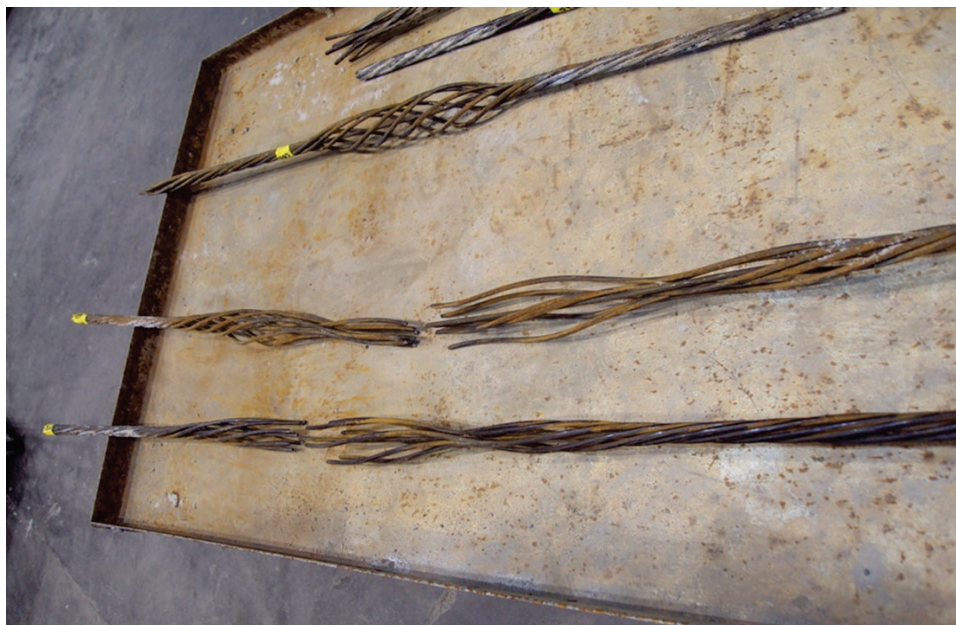
Figure 2.23. Example of “bird cage” effect for pulled cables.

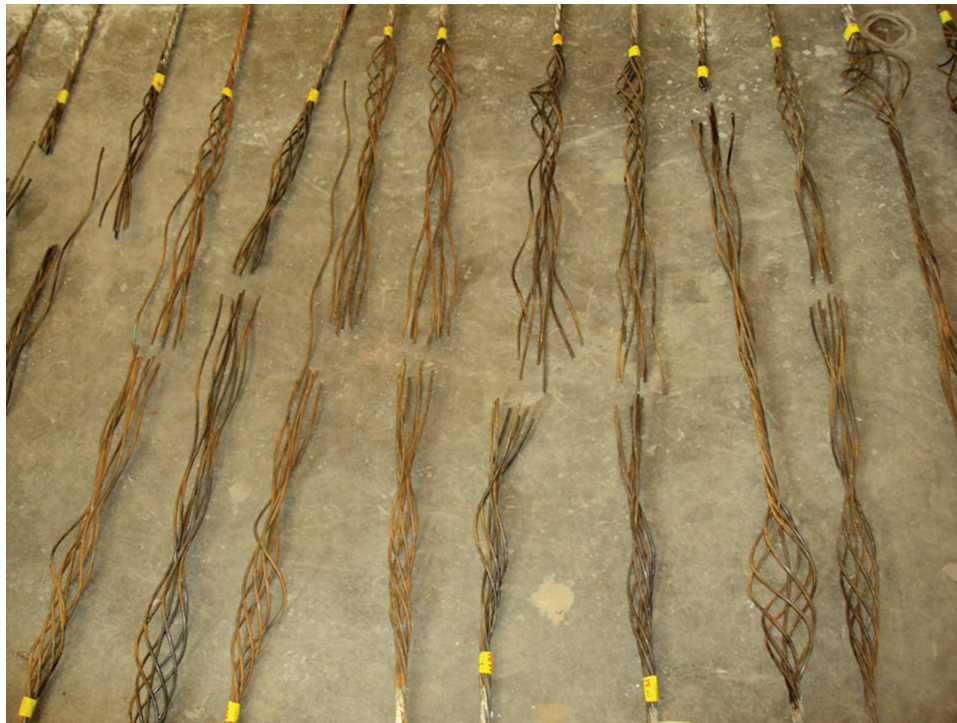
Figure 2.24. Successful pull-test results for corroded specimen.

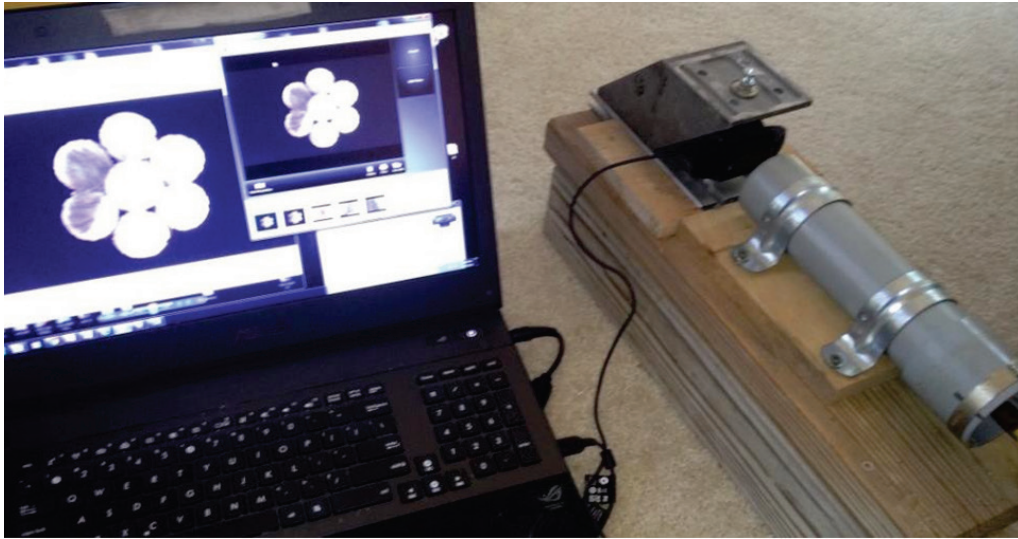
Figure 3.3. Optical scanning platform showing the scanning software.

Image processing was used to provide an end view of the cable from the calibration image, and contrast thresholding provided an image where the cable end was white and the background was black (Figures 3.3 and 3.4). With the calibration image, the area of an individual pixel could be calculated. Individual wires could touch and interfere with the computational geometry techniques being used for determining the geometry of the individual wires. If this occurred, the image processing software would allow the user to segment the cable into individual wires by making infinitely thin cutting lines between the wires (Figures 3.5 and 3.6). Then the computational geometry engine would compute the areas, perimeters, eccentricities, long axis length, and short axis lengths of the individual wires (Figure 3.7).
